UNDERWATER BRIDGE INSPECTION REPORT

STRUCTURE NO. 27532

CROW RIVER

DISTRICT 5 –HENNEPIN COUNTY

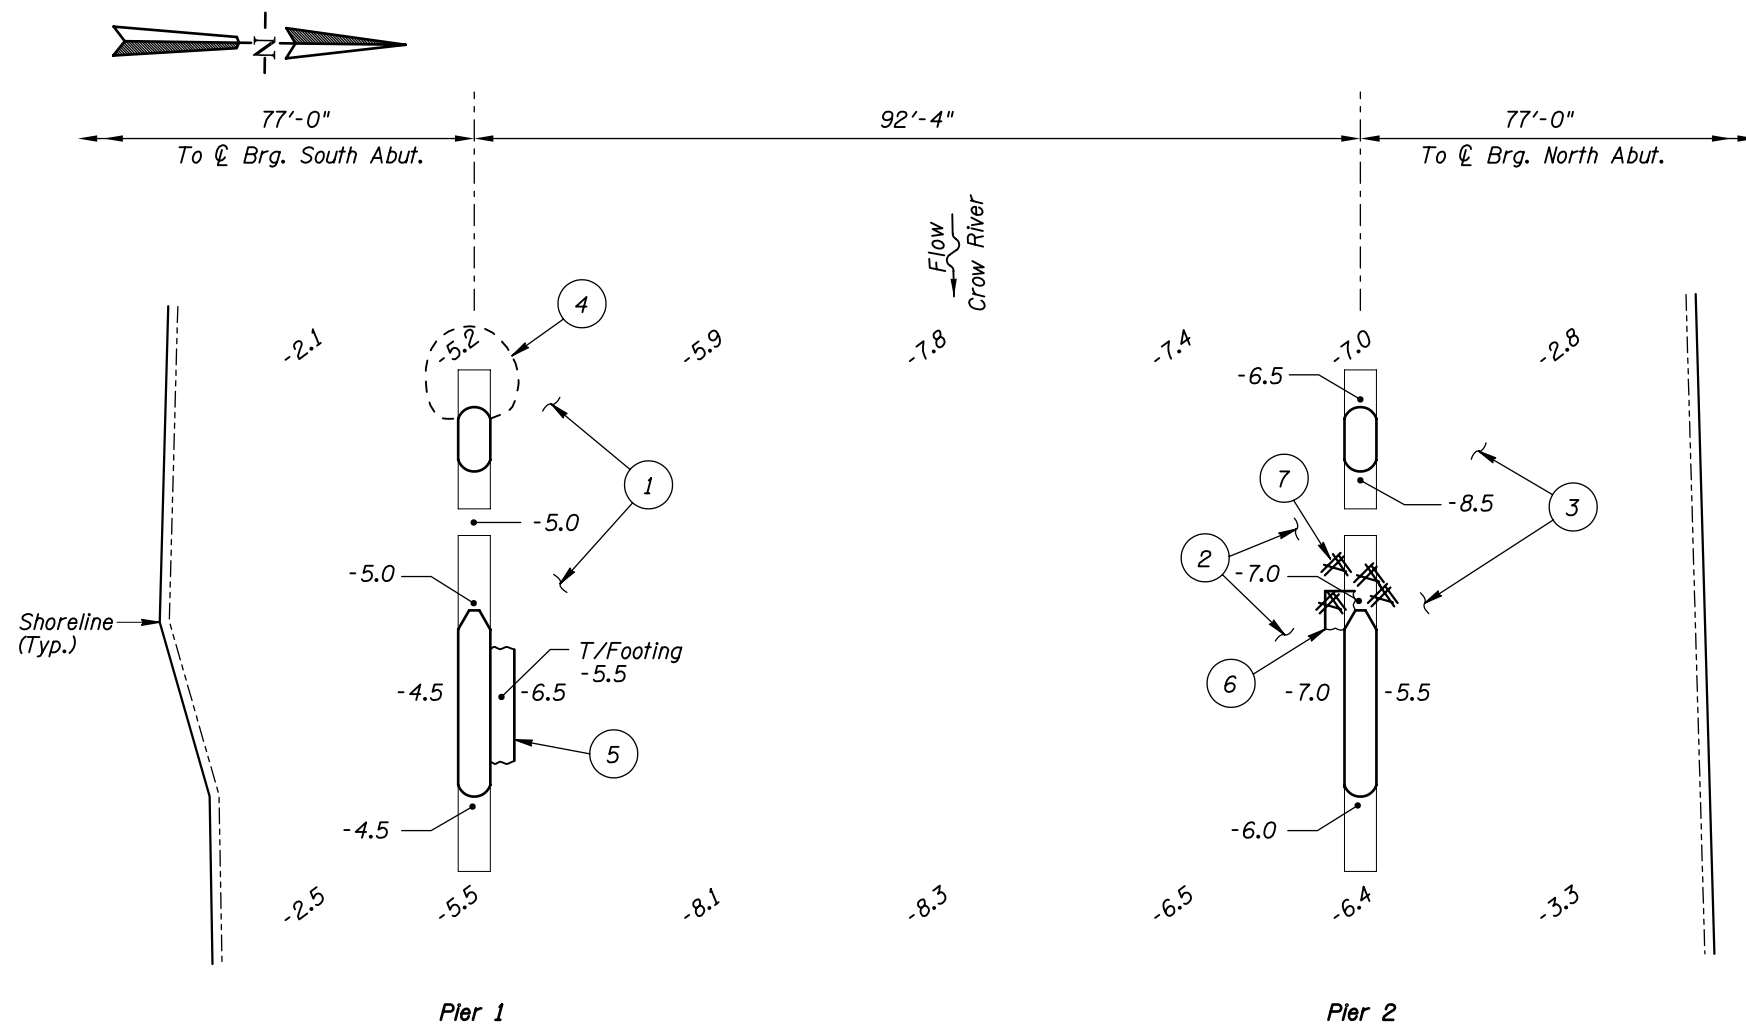
SOUNDING PLAN

- The channel bottom consisted of sandy gravel and 8-inch-diameter riprap with up to 4 inches of probe rod penetration.
- The channel bottom consisted of sandy gravel with up to 4 inches of probe rod penetration.
- The channel bottom consisted of riprap up to 2 feet in diameter.
- A scour depression, 0.5 feet deep and 3 feet in radius, was observed at the upstream end of Pier 1.
- The footing was exposed along the north face of the downstream section of Pier 1 with up to 1 foot of vertical face exposure.
- The footing was exposed at the upstream nose of the downstream portion of Pier 2 with up to 5 inches of vertical face exposure.
- A minor accumulation of timber debris, with pieces up to 6 inches in diameter, was observed at the upstream nose of the downstream portion of Pier 2.

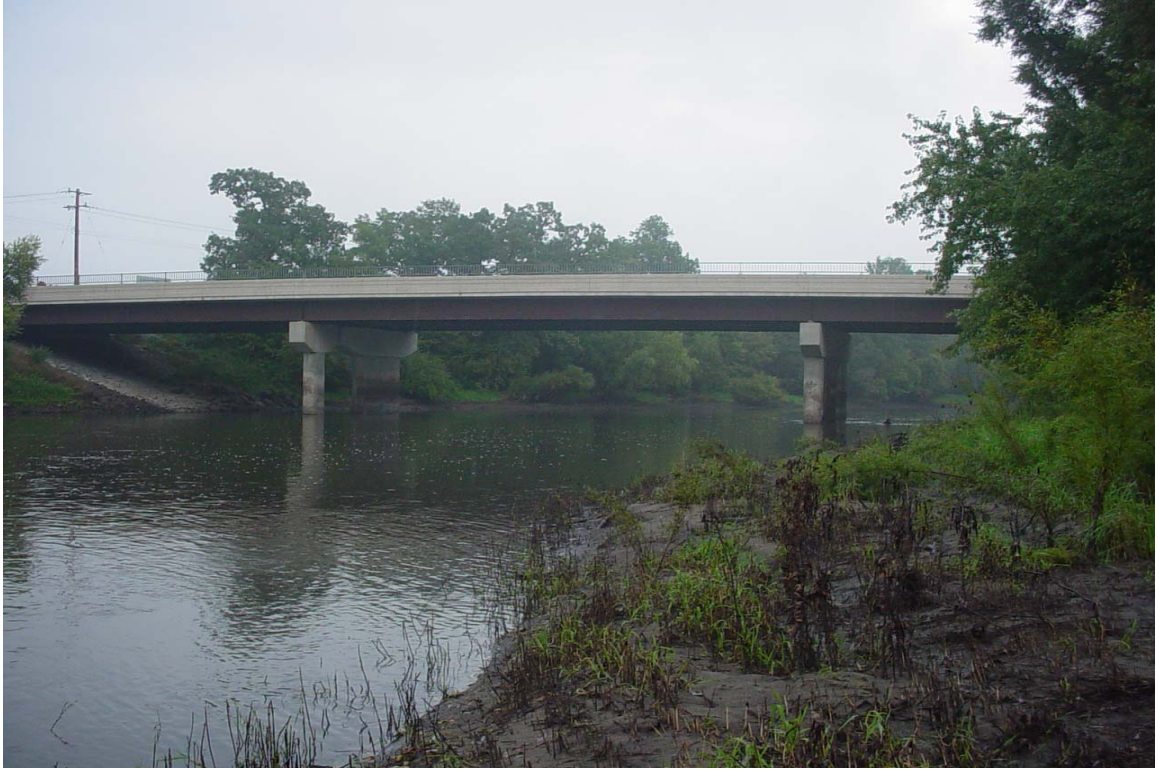
Photograph 1. Overall View of Structure, Looking Northeast.
